Geotechnical Engineering Report

Smyer Road Evaluation

Smyer Road
Mountain Brook, Jefferson County, Alabama

ECS Project Number 30:1857

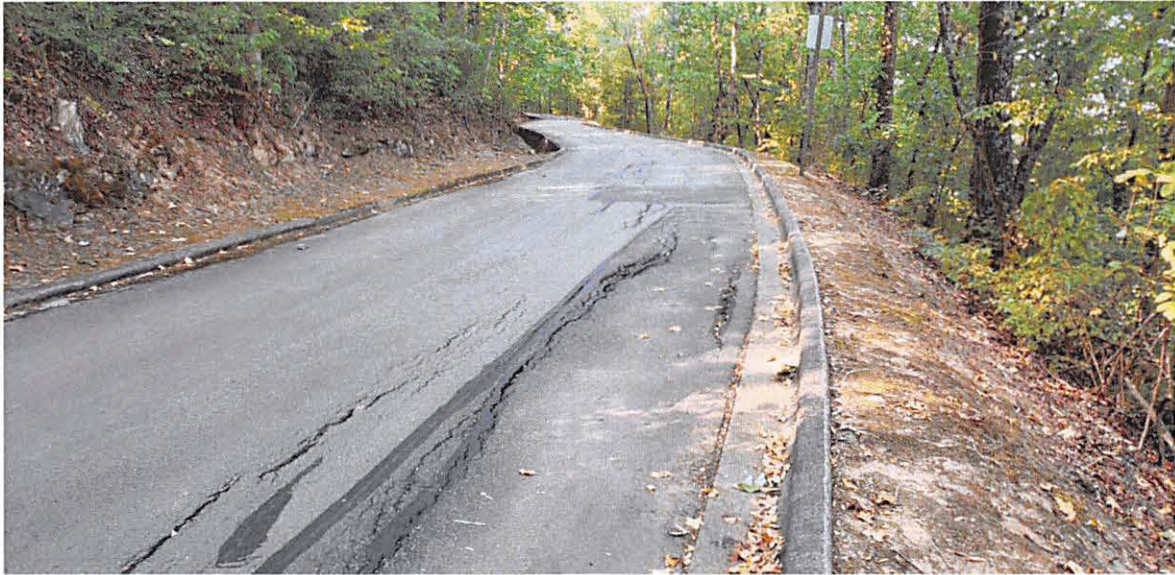
Pavement rutting and tearing along this portion of Smyer Road was noted, particularly in the westbound lane of the roadway. Typical views of the pavement conditions are provided in Figures 2.3.1 and 2.3.2. The type of distress is typically evident of slope movement/settlement of the pavement subgrade soils. (This is further discussed in Section 3.3 and Section 5.)

Figure 2.3.1 – Typical View of Pavement Rutting and Tearing

Based on the results of our subsurface evaluation and our observations at the site, it appears the roadway is exhibiting a wedge failure. In this failure mode, a wedge of soil placed against the slope tends to move as a single mass. This wedge appears to consist of the fill placed for the roadway from the approximate centerline of the roadway to the downslope side of the roadway.

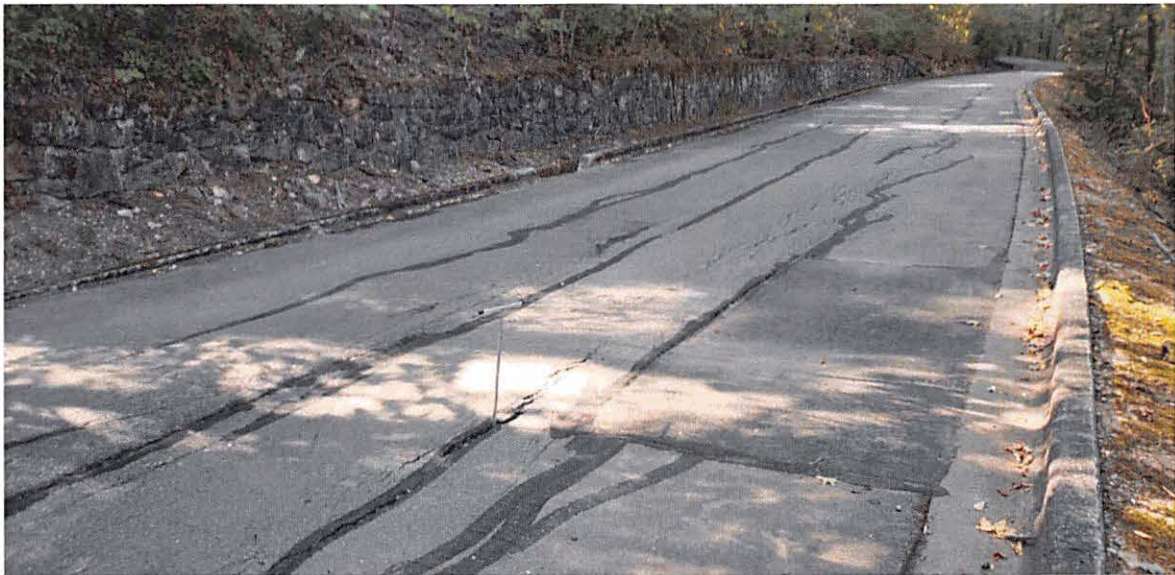
Figure 2.3.2 – Typical View of Pavement Rutting and Tearing, Area of Prior Crack Seal is Visible

Option 1 – Seal and Patch/Do Nothing: We understand due to the low traffic volume for Smyer Road, the City may consider a program of patching and crack sealing, as needed. This should be considered a 'Do Nothing' approach. This will require continual maintenance, generally yearly, in order to seal cracks and patch where rutting is significant. This would be performed at the direction of Public Works personnel on an as-needed basis. At a minimum, these cracks should be regularly filled in order to limit additional surface water from entering the subsurface and increasing the problem conditions at the site.

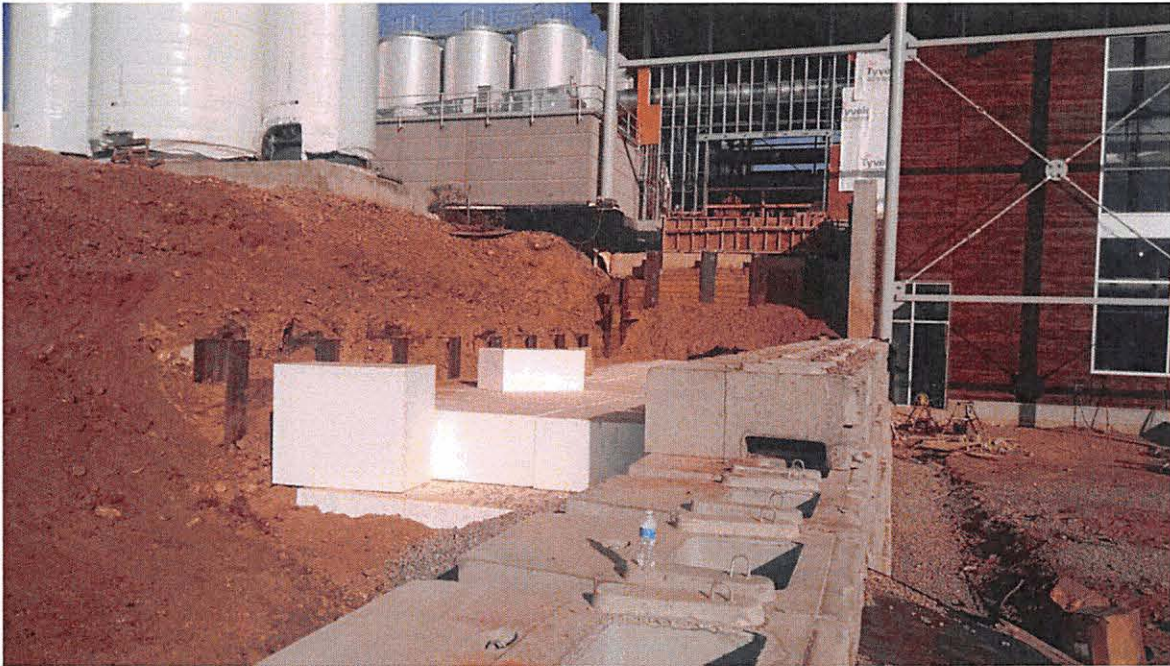
Option 2 – Limited Depth Replacement: An intermediate option for repair that will provide some reduction in load on the slope (therefore on the driving forces on the slope movement) is a limited depth undercut of the stone backfill at the site and replacement with expanded polystyrene (EPS) block fill. EPS is used extensively worldwide in applications where the typical heavy weight of soil or stone backfill will cause failure or intolerable settlement of a structure and replaces that fill with a lightweight alternative that can support roadways. A significant example of such is the Interstate system in the area of Salt Lake City, Utah.

**Figure 5.1.1 – Example View of EPS Backfill Behind Gravity Retaining Wall
(from Author's Personal Photos)**

We anticipate that the depth of replacement of the existing stone backfill with EPS may be on the order of 5 to 8 feet but it could be deeper. Evaluation of this option will require additional information to determine the actual depth of removal and replacement. ECS should perform a Global Stability Analysis of the conditions at the site in order to evaluate the actual depth and extent of replacement. In order to perform the analysis, we also request topographical survey information of regular cross-sections along the roadway.

An important component of this repair approach would be the installation of a drainage system within the EPS backfill. Hydrostatic pressure within the subgrade is a likely driving force behind the slope movement, so installation of relief of the force is important. It should also be anticipated that this approach would require the full depth replacement of the existing pavement section at the site after the EPS backfill has been placed. Typically, a minimum of 1 foot of soil and stone backfill will be required as a cushion between the EPS and the newly replaced roadway.

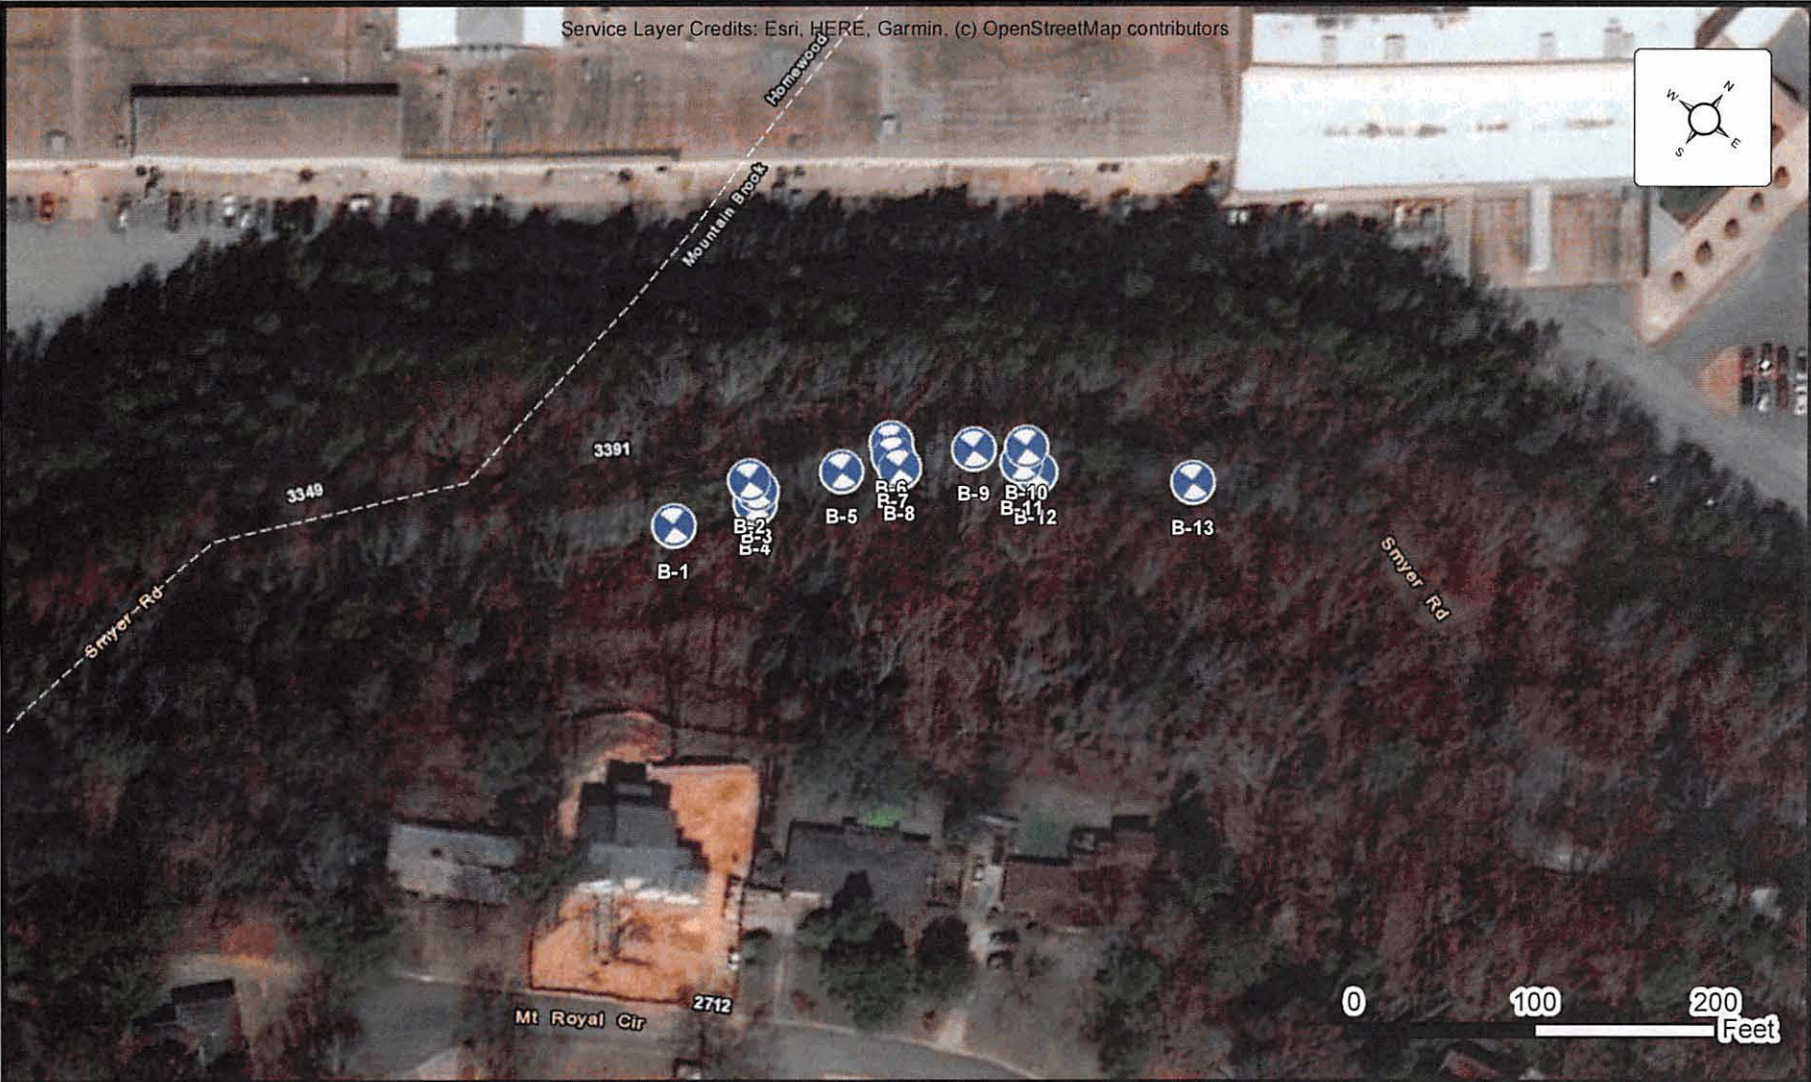
Boring Location Diagram SMYER ROAD EVALUATION

The site subsurface conditions were evaluated with thirteen (13) SPT borings (B-1 through B-13) at the approximate locations shown on the Boring Location Diagram in Appendix A. The quantity of borings, boring locations, and drilling depths were discussed with the project team prior to completing this subsurface exploration.

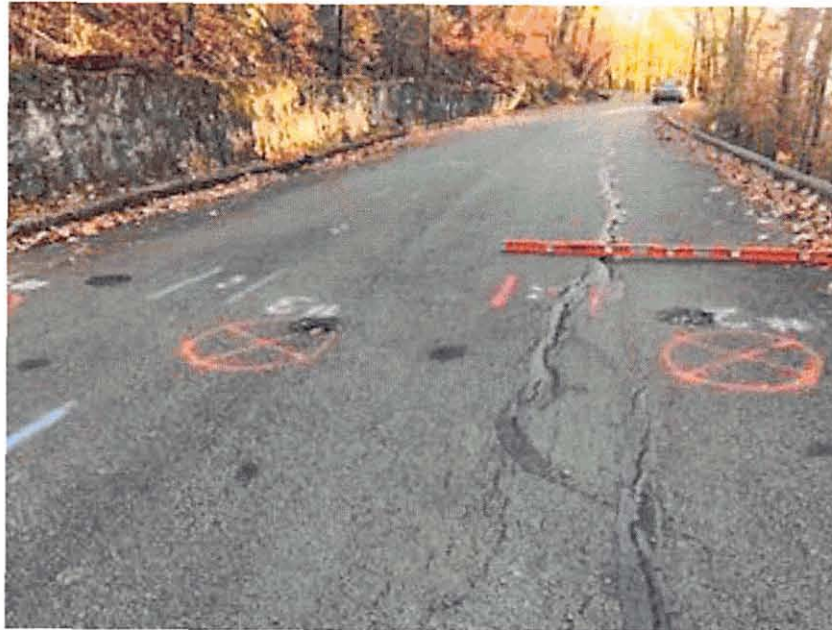
Photograph 2, Area 1: General Conditions at Road Surface

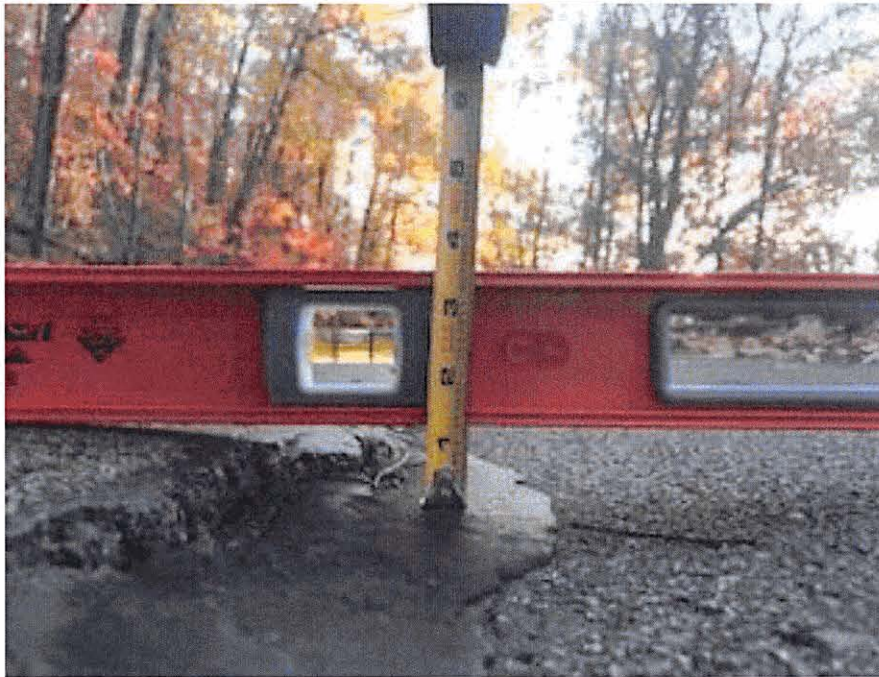
Photograph 3, Area 1: Rutting Depth of 1.5"

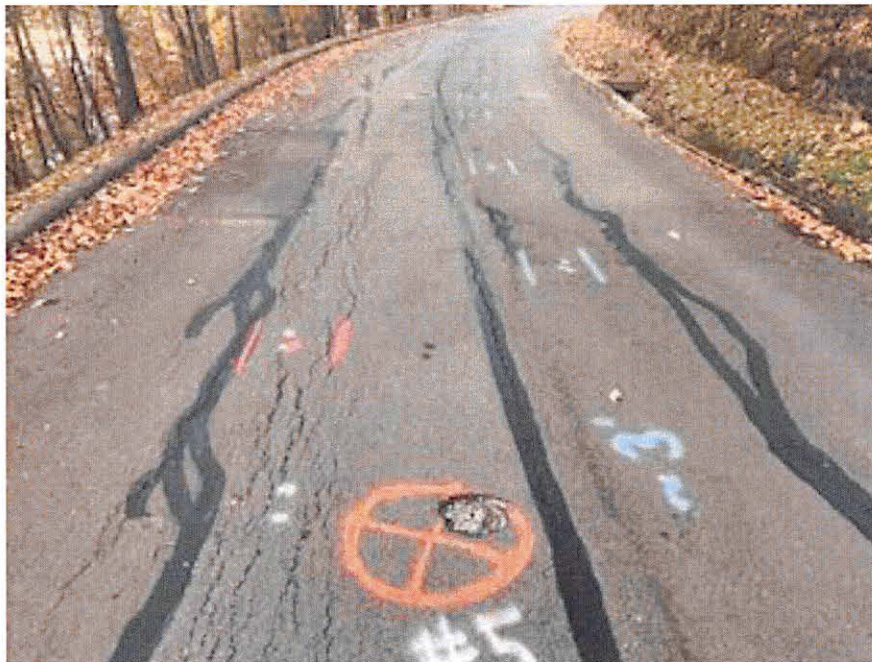
Photograph 4, Area 2: General Condition at Road Surface

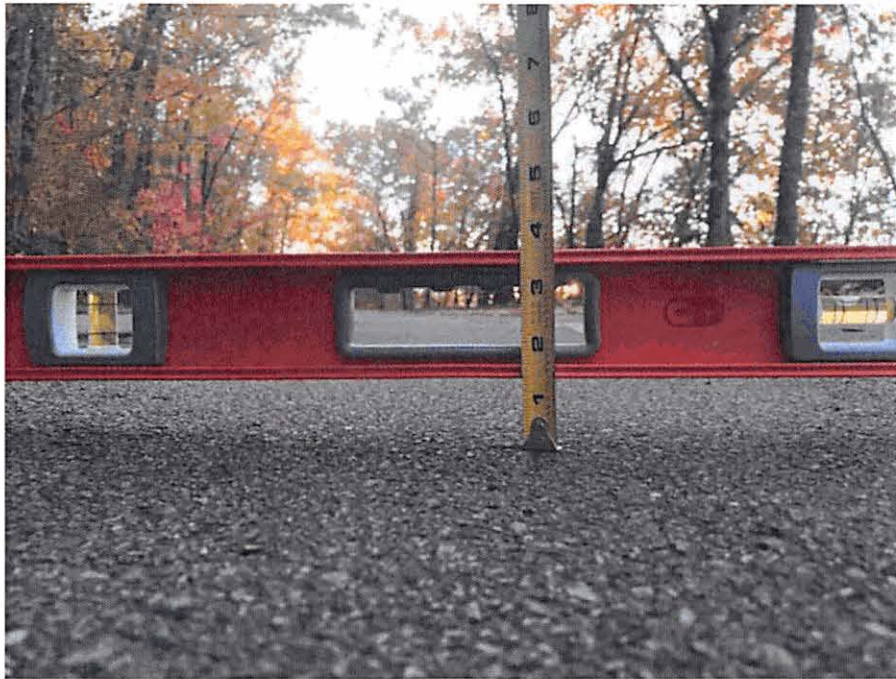
Photograph 5, Area 2: Rutting Depth of 1.5"

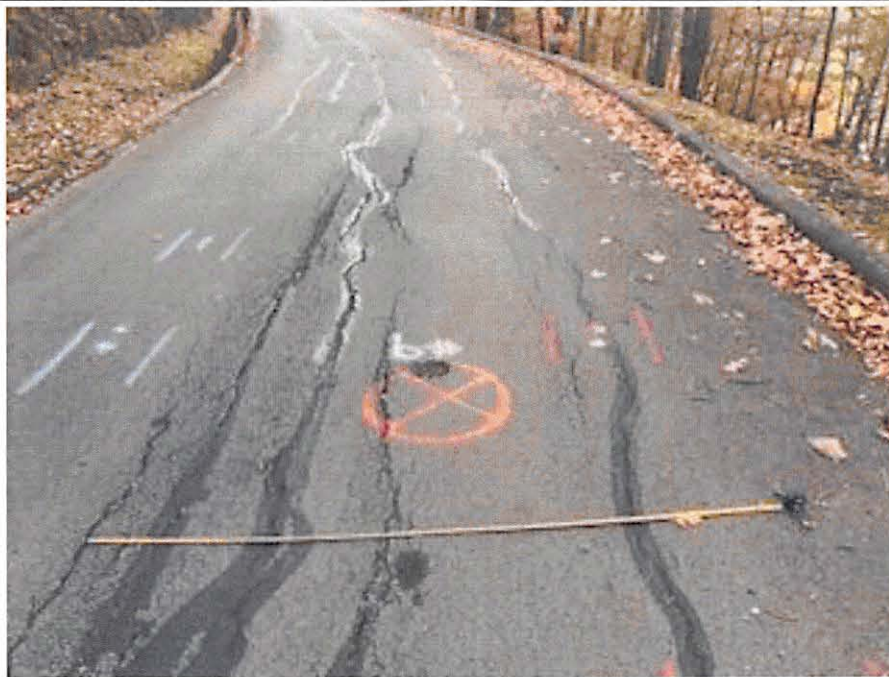
Photograph 6, Area 3: General Condition at Road Surface

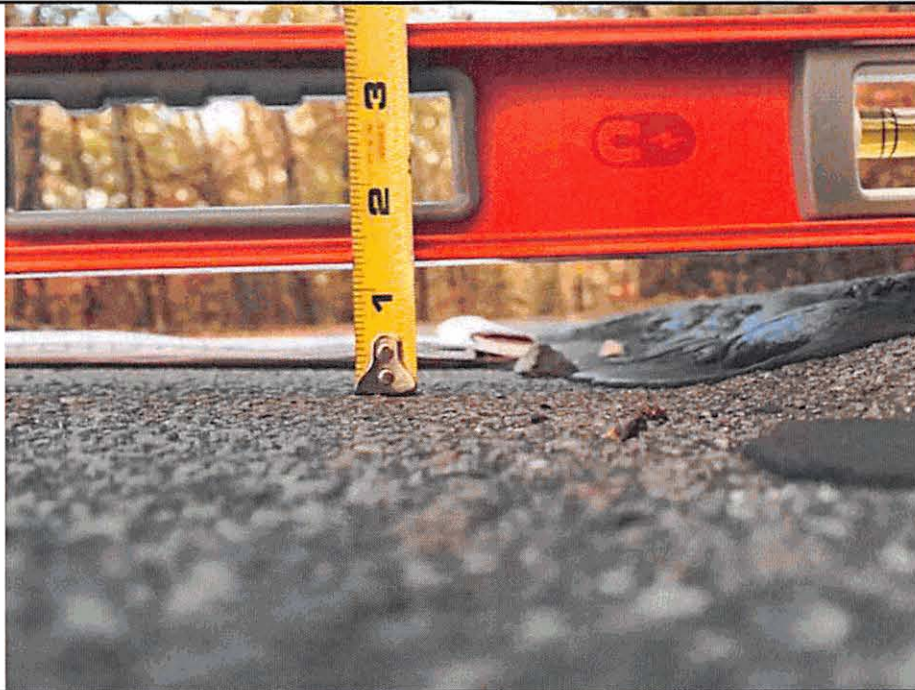
Photograph 7, Area 3: Rutting Depth of 1.5"

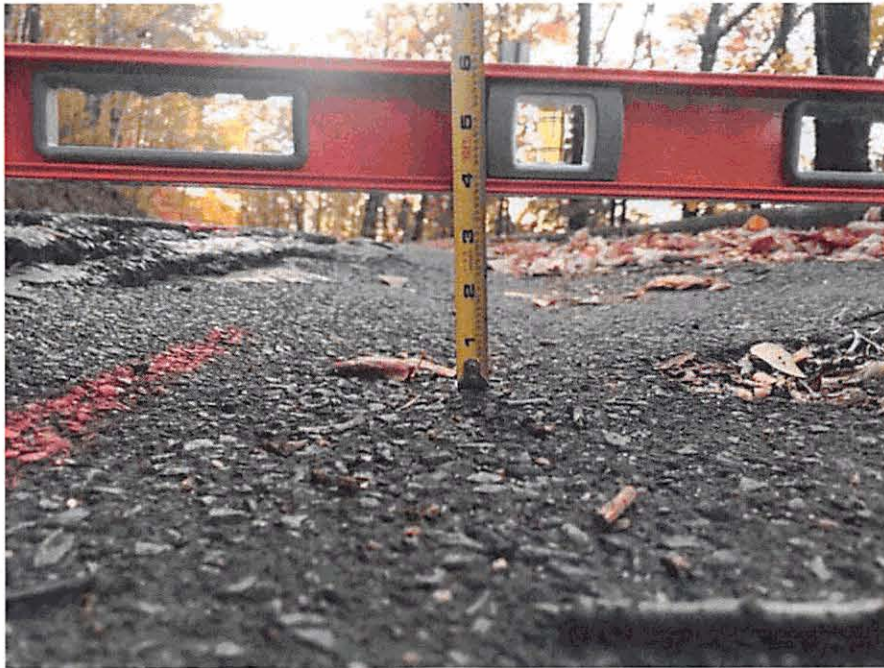
Photograph 9, Area 4: Rutting Depth of 3.75"

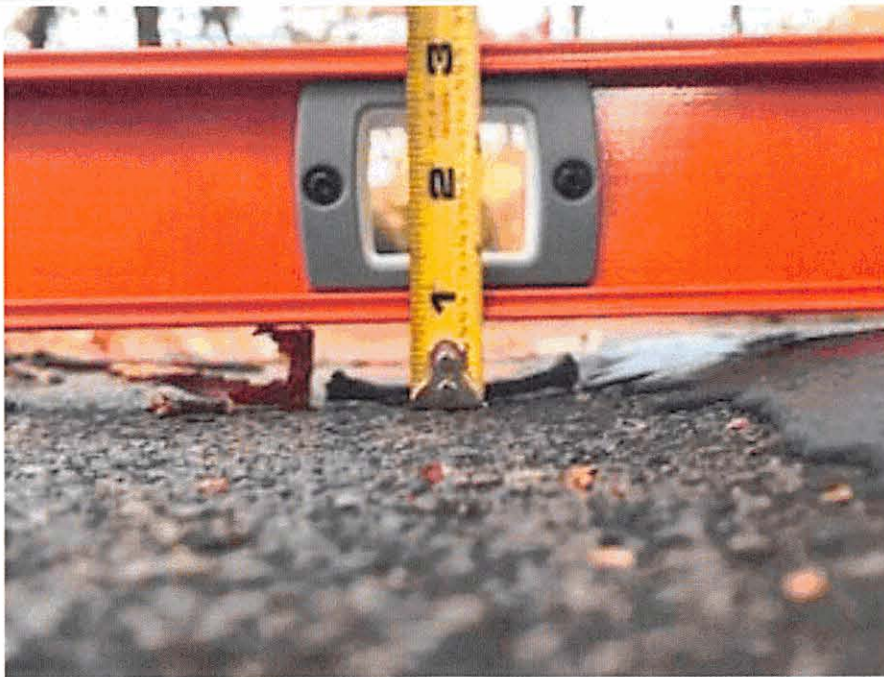
Photograph 10, Area 5: Rutting Depth of 0.75" (Surface Road Condition same as Area 1)
